Parking Lots...to Creeks...to Puget Sound

Melinda J. Fohn

Kitsap County Health District

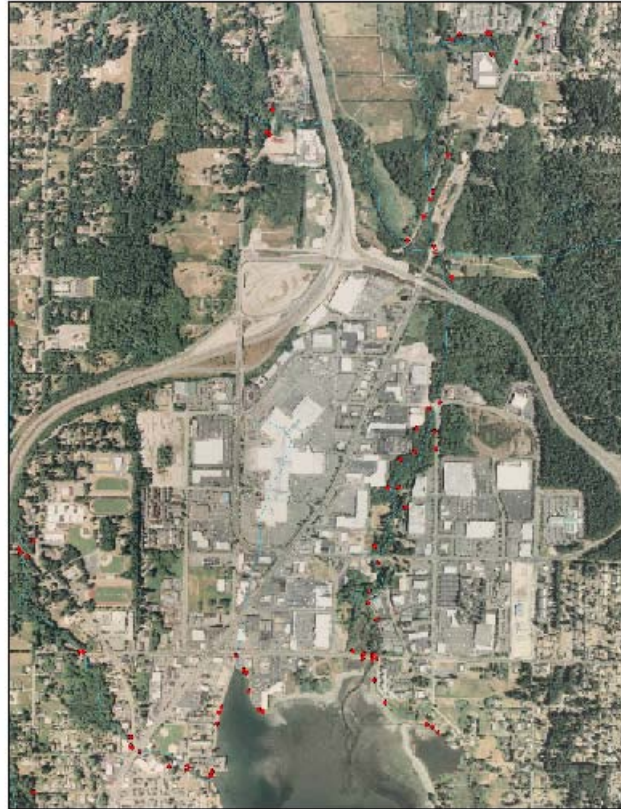
Figure 1. Aerial view of Silverdale, stormwater outfalls are shown in red.

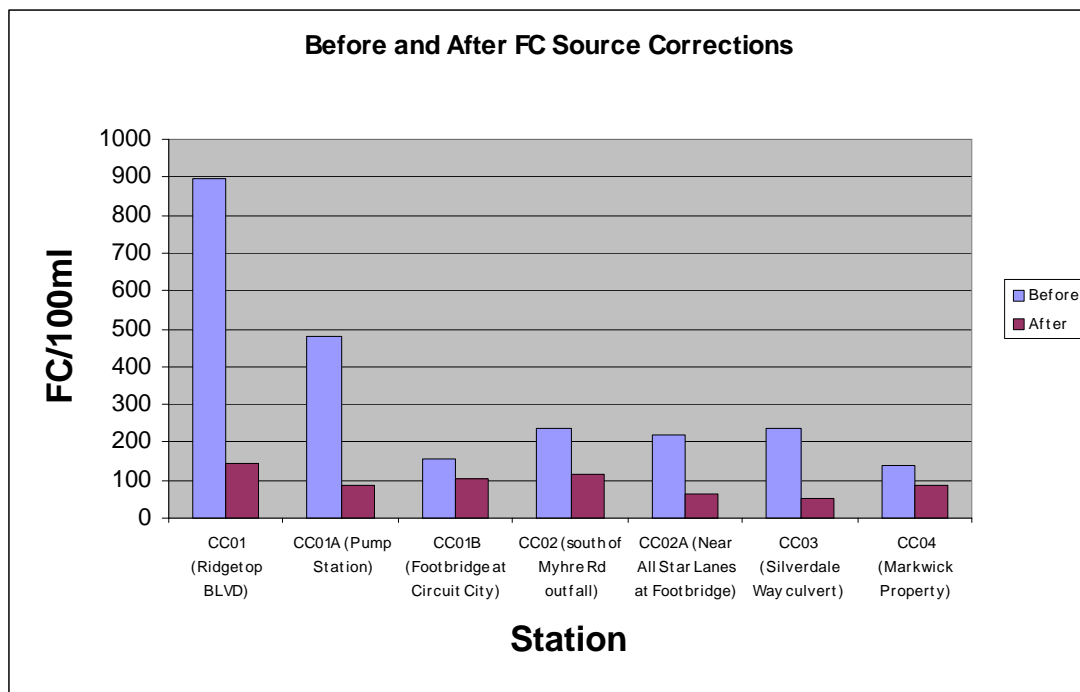
Figure 5. FC geometric means at Clear Creek stream station before and after 2006 inspections and corrections.

FC reductions were apparent at stream monitoring stations in the commercial corridor of Silverdale after the FC identification and correction activities for both the water year data and dry season data alone. Figure 5 shows the dry season data before and after the first phase of the project. The FC geometric mean is shown on the y-axis and the stations, downstream on the left and moving upstream to the right, on the x-axis. Statistically significant reduction in FC concentration ($p=0.05$) occurs at stations CC01 and CC02A. The failing OSS is located directly upstream of CC01 and was corrected before the dry season sampling period. The remaining stations are influenced by stormwater runoff from the commercial properties.
